# Oconto County Lakes Project

## MACHICKANEE FLOWAGE STUDY

### SUMMARY REPORT

2018

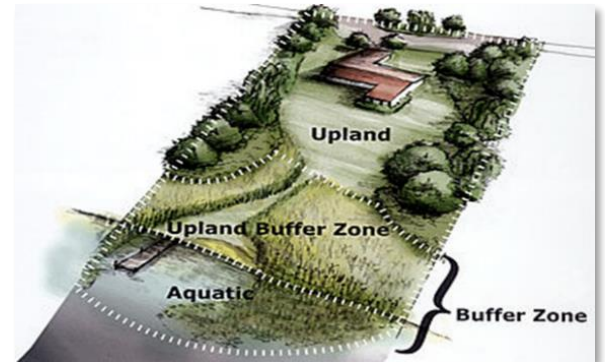
- Shorelands around Machickanee Flowage were surveyed in August 2017. Much of Machickanee Flowage's shoreland is healthy, but many stretches are in need of restoration.

| Total lakefront footage | No. Riparian lots | Measured shoreland disturbance (feet) | Measured shoreland disturbance (%) |
| 38,794 | 221 | 9,964 | 26% |
